Inland West Watershed Initiative (IWWI)

Stream Sensitivity to Management

Riparian Health

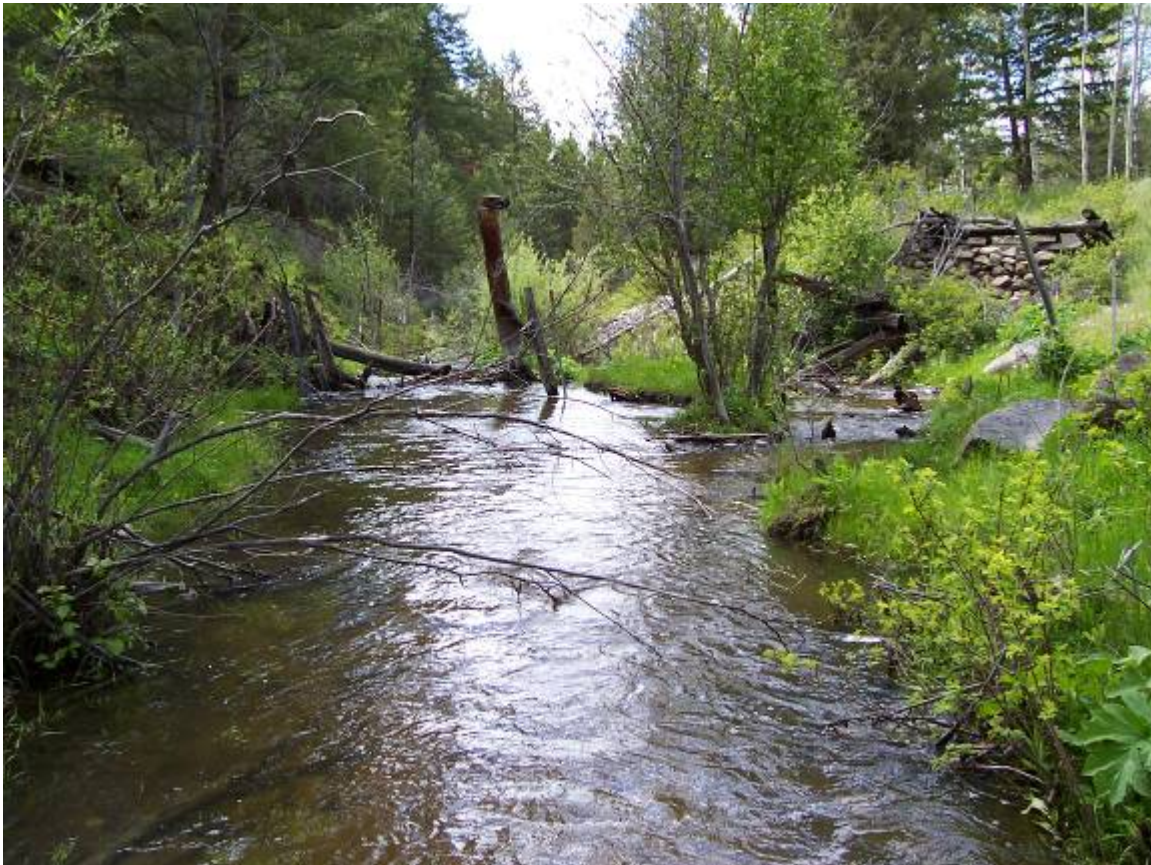
Photo: Dry Cottonwood Creek on the BDNF during spring runoff. This reach was non-functioning during the 2002 Hansen assessment.

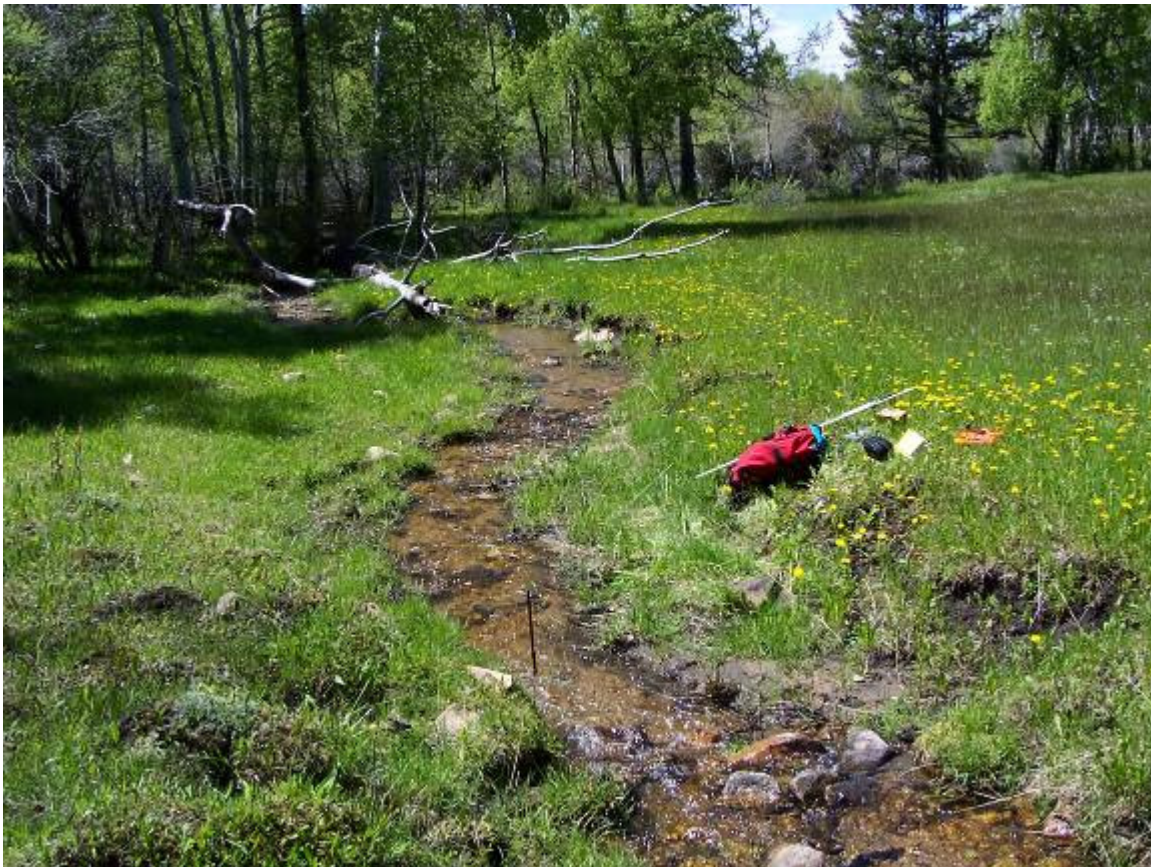
The non-functioning status represents a meadow section where livestock concentrate during warm weather and exert high pressure on streambanks, soils and vegetation. Existing condition has degraded to the point that recovery will occur slowly. The road system that follows the stream receives light use, and does not constitute a serious sediment source. The Hansen assessment in 2002 determined that lower areas of the BDNF on Perkins Gulch have highly variable condition. In addition, the road constitutes a serious sediment source in other areas of the watershed.

Photo: Perkins Gulch on the BDNF lacks woody vegetation. This reach scored functioning at-risk during the 2002 Hansen assessment and nonfunctioning during the USFS PFC assessment.

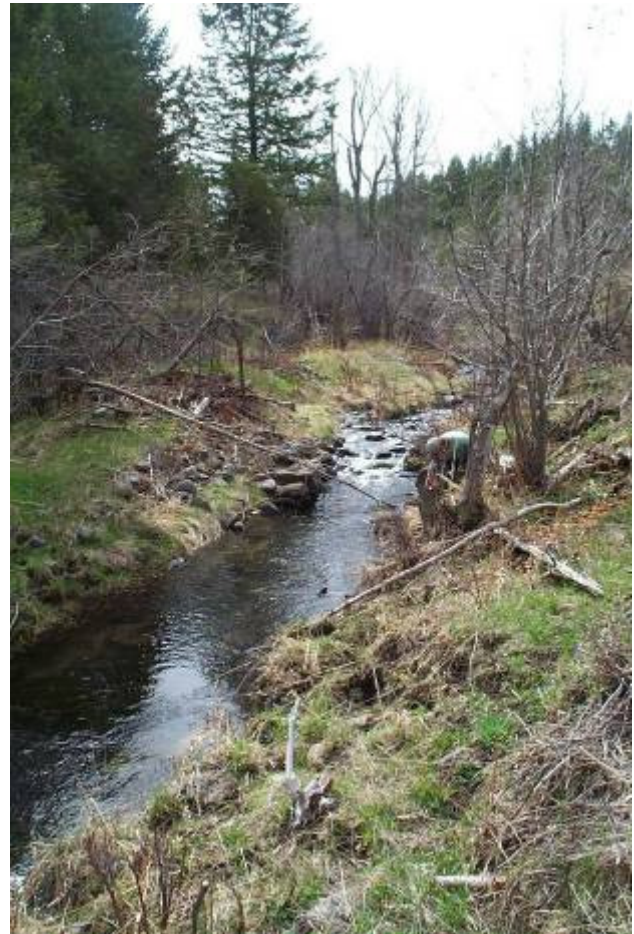
Photo: Fish habitat conditions on private lands, upper Peterson Creek.

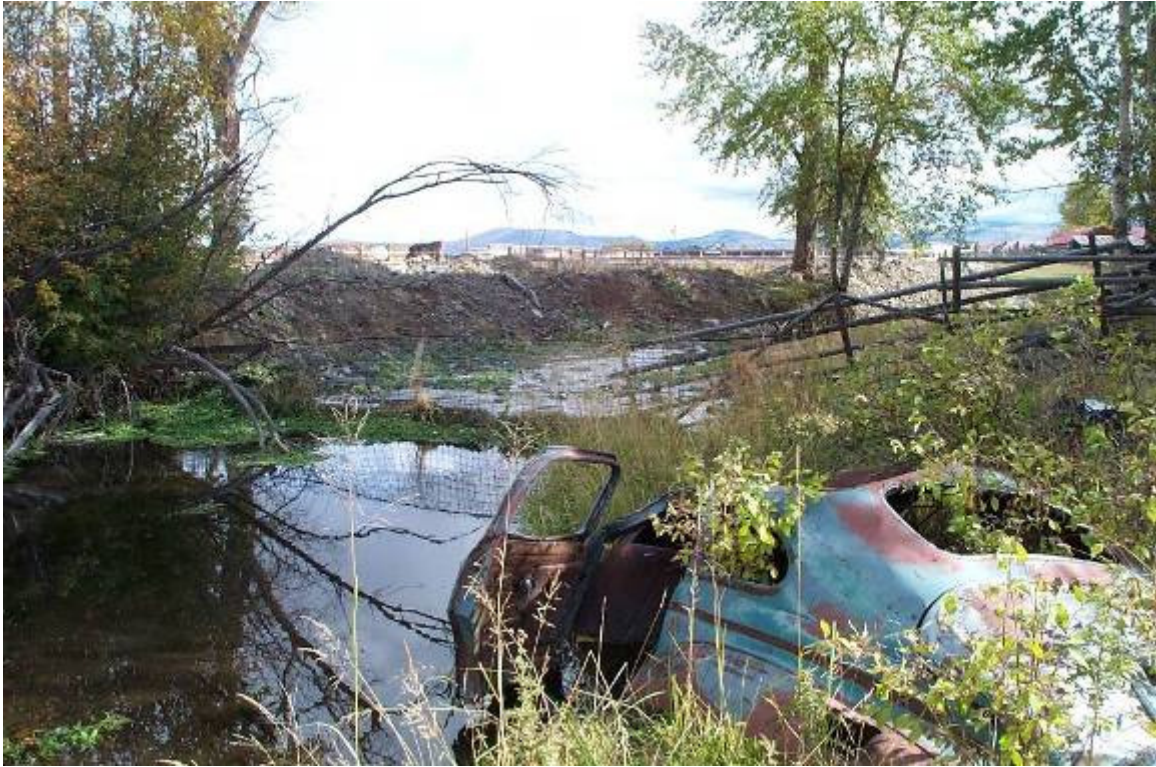
Photo: A car body, over widened stream, and feed lot on private lands on lower Cottonwood Creek. The feedlot has been re-contoured, fenced, and revegetated to mitigate nutrient runoff from the site in coordination with the WRC.

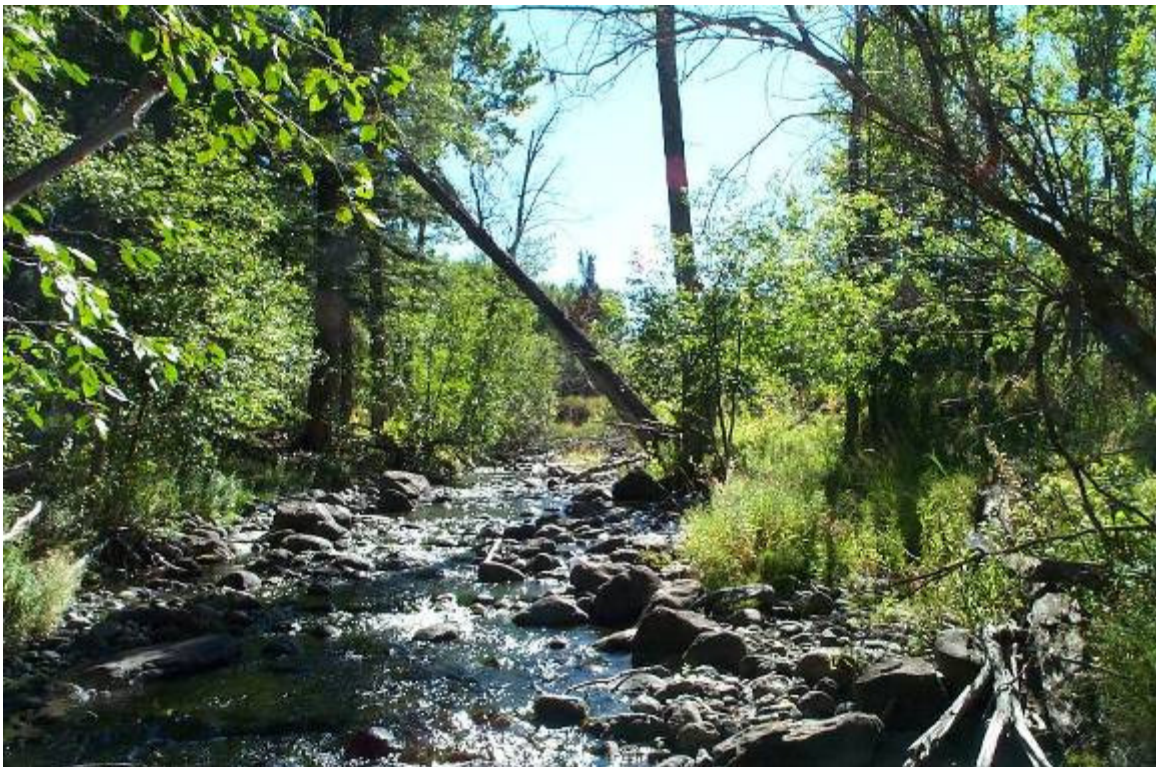
Photo: Fish habitat conditions in the Middle Fork of Cottonwood Creek on the BDNF in 2002.

A USFS detailed survey of the Middle Fork of Cottonwood Creek from 1992 found previous logging within the riparian zone, a considerable amount of erosion, and algae covering the substrate.
